Longitudinal Joint Systems in Slip-Formed Rigid Pavements

Volume V - Summary of
Field Test Results from
Chicago O'Hare
International Airport

Ernest J. Barenberg
University of Illinois
Urbana, Illinois

February 1983

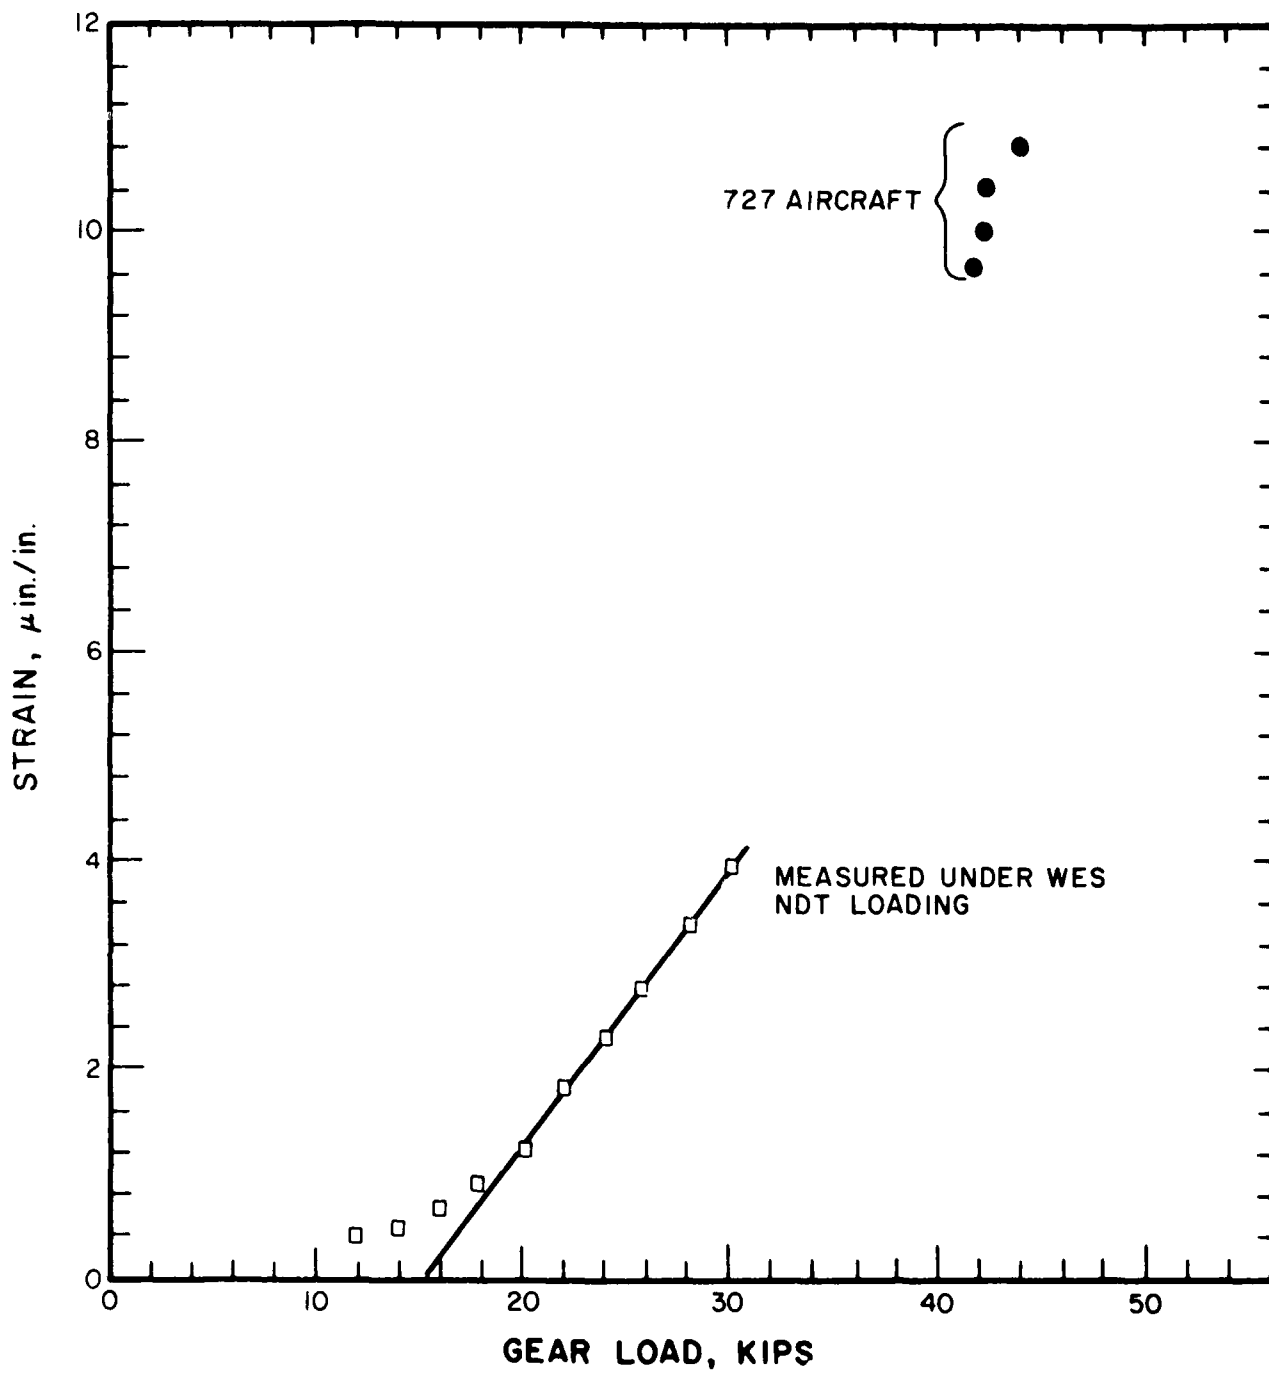
Figure 14. Typical Strain Results from Site #4, at Dowelled Transverse Joint

Measured strains in the pavements at Site 4 under both aircraft and vibratory loads are shown in Figures 14, 15 and 16. Results shown are the actual strains as measured without correction for load location with respect to the gages and for the location of the gages in the pavement system. It should be noted, for example, that the Carlson wire strain gages are located between two and one-half and three inches from the top and bottom faces of the slabs. To obtain maximum strains in the slab the measured strains will have to be adjusted to convert the measured strains to the theoretical maximum strains. This adjustment is discussed later in the section on the interpretation of the results.

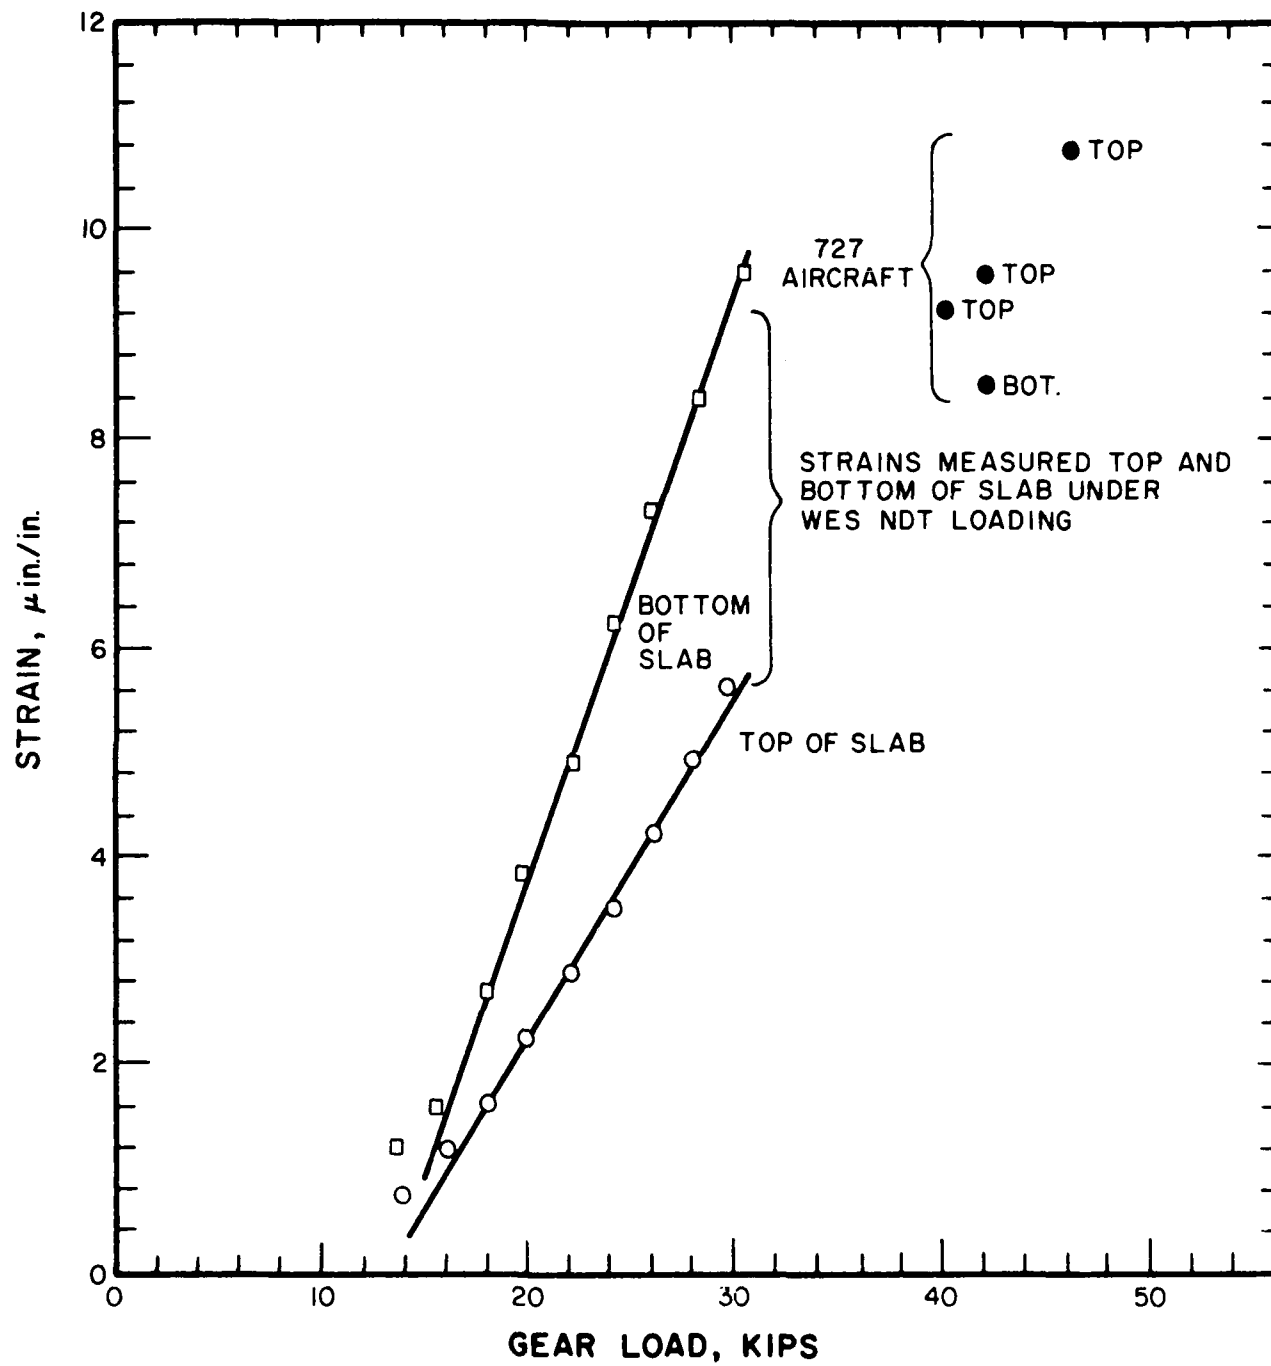
Figure 15. Typical Strain Results from Site #4,
at Center of Keyed Longitudinal Joint

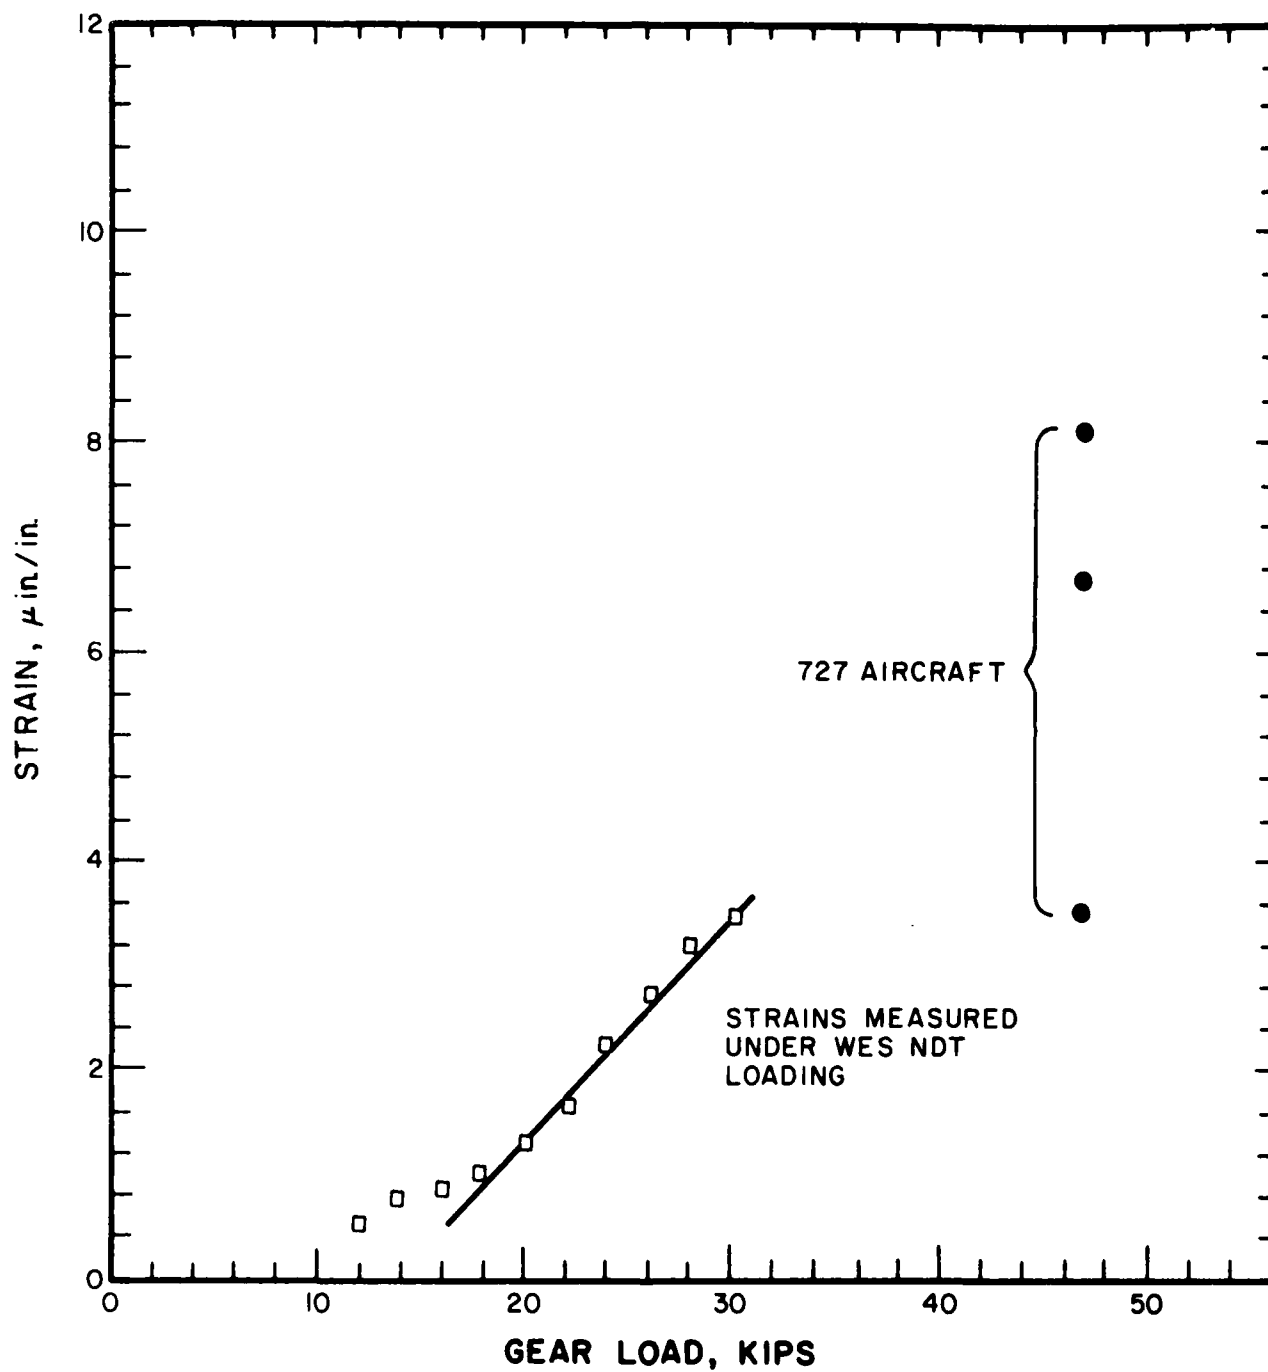
Figure 16. Typical Strain Results from Site #4,
Load Placed near the Slab Corner

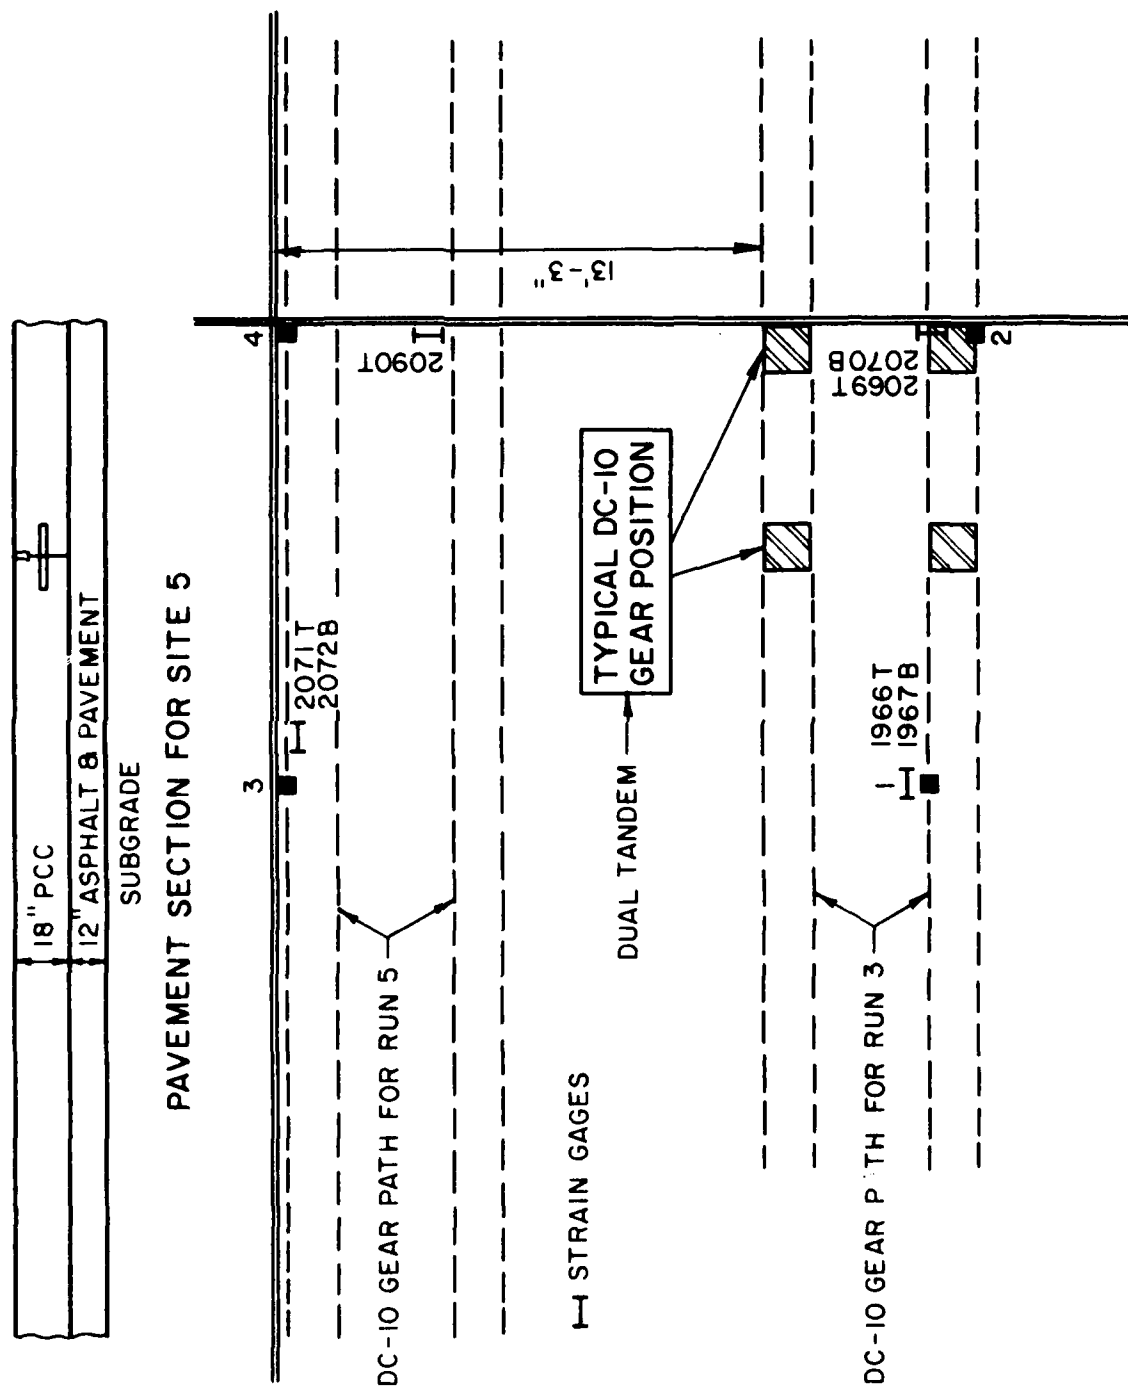
Figure 17. Pavement Section, Gage Locations, and Typical Gear Path for Aircraft Loading at Site #5

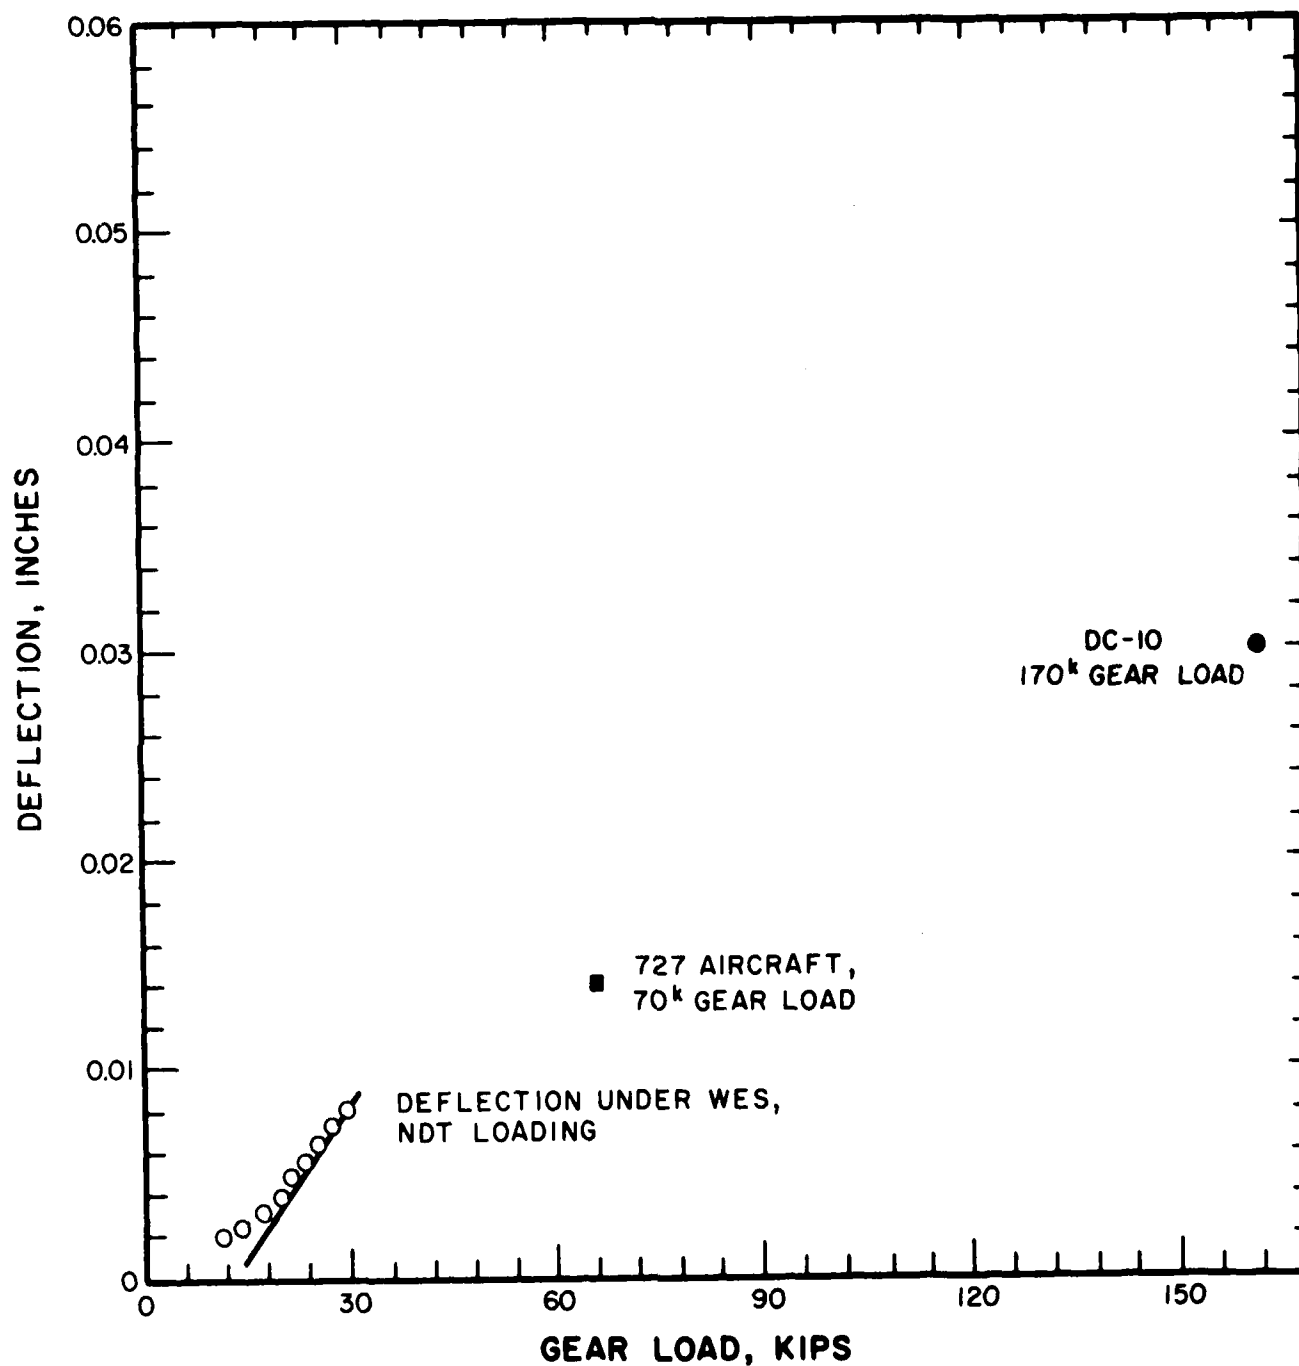
Figure 18. Typical Deflection Results Collected from Site #5,
Load at Center of Dowelled Transverse Joint

Figures 18 and 19 show the measured deflections at two locations for Site 5 under a range of vibratory loads and for the B-727 and DC-10 aircraft. Unfortunately, deflection gages at two other locations were not operating properly at the time these tests were run. Thus the NDT geophone results at these locations are also not shown as the results do not show any trends significantly different from those shown in Figures 18 and 19.

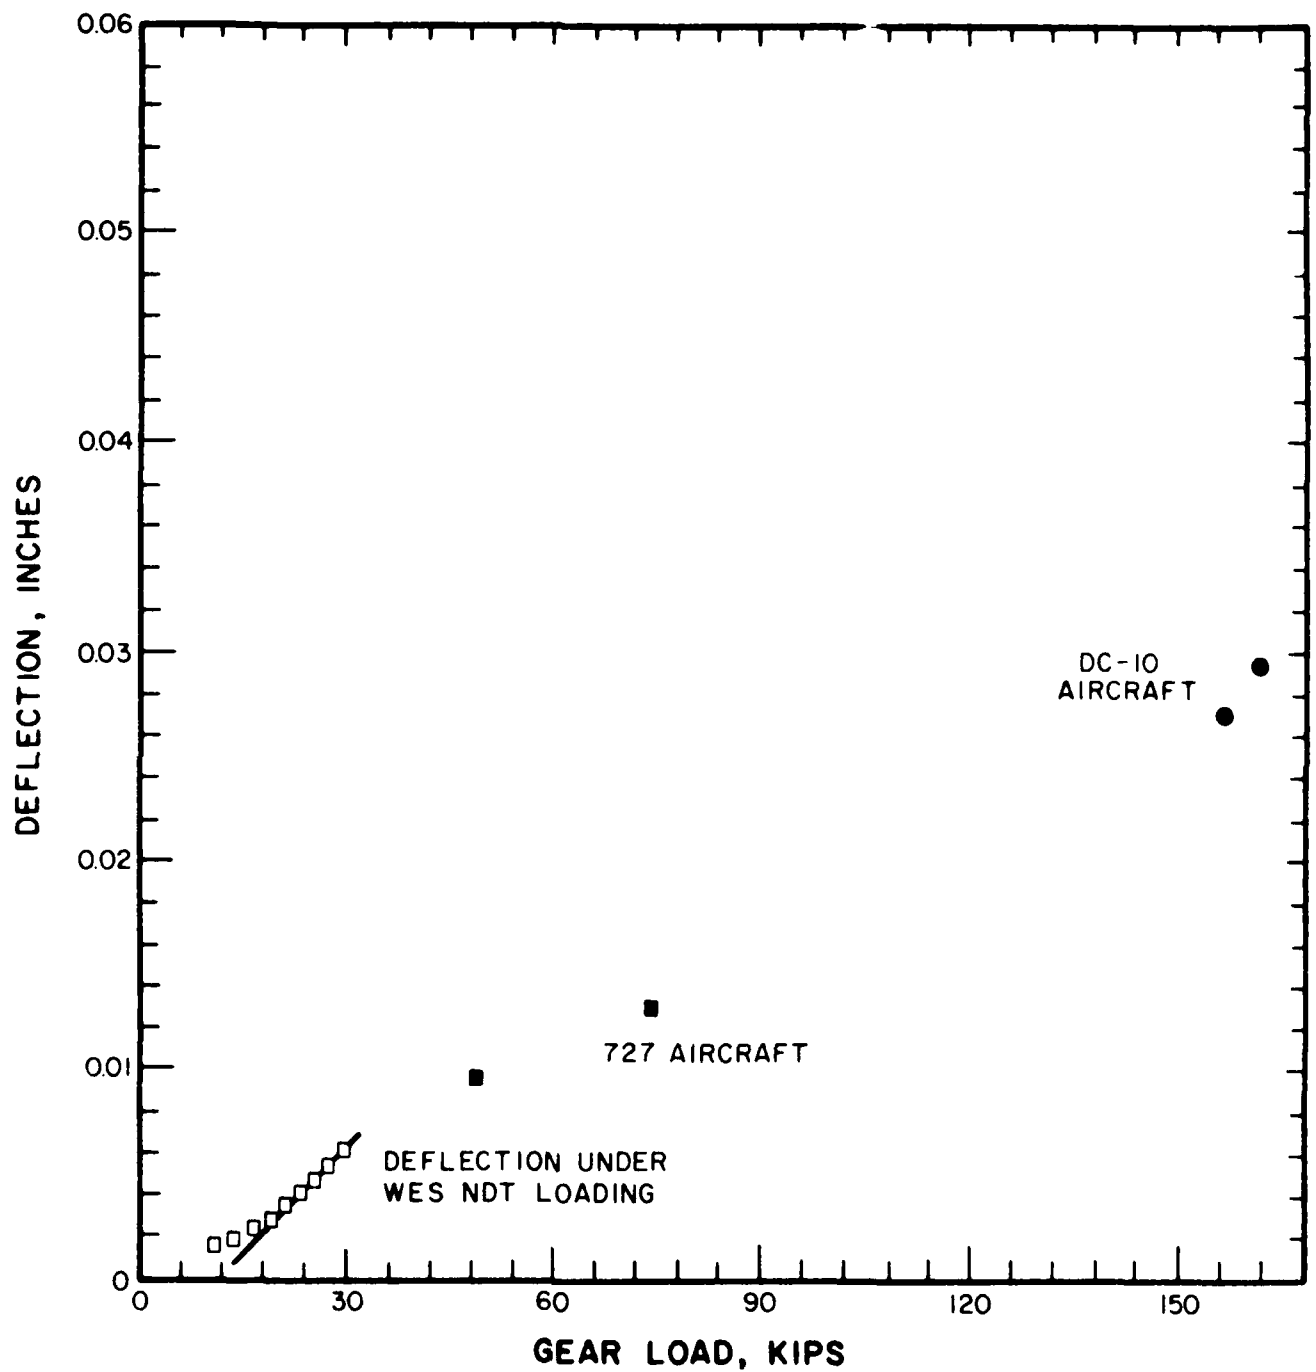
Figure 19. Typical Deflection Results Collected from Site #5, with Load at Center of Slab

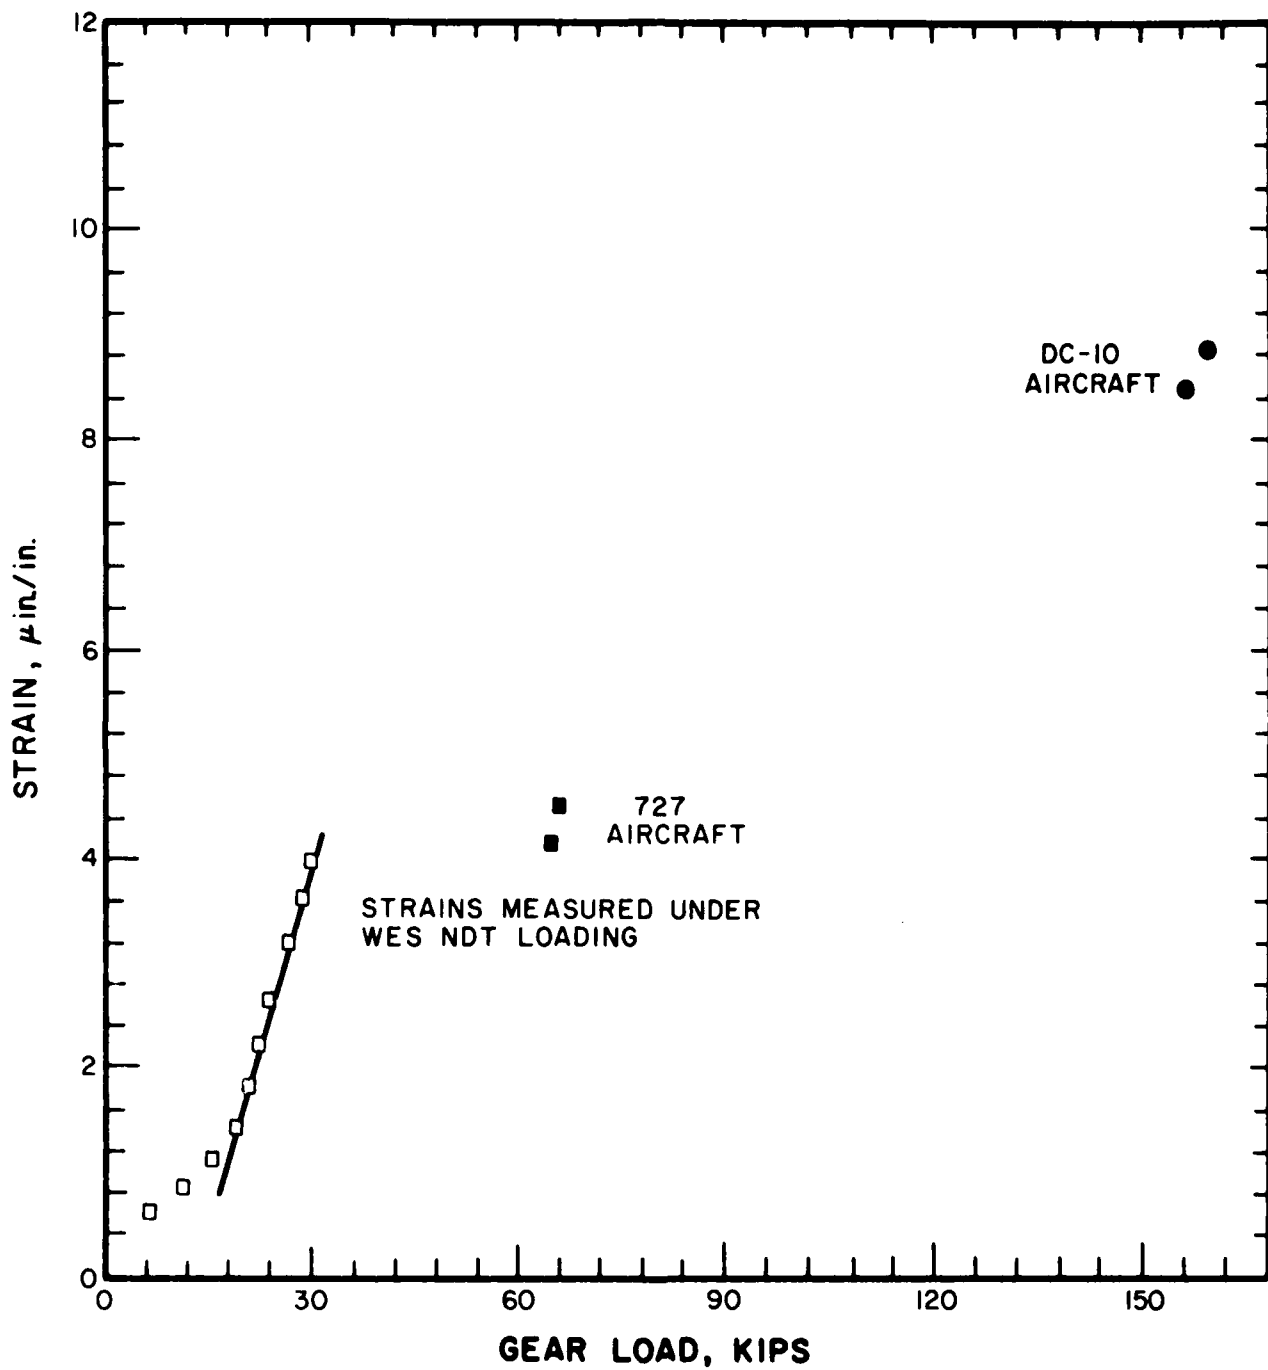
Figure 20. Typical Strain Results from Site #5,
with Load at Center of Slab

Measured strains from two locations at Site 5 under vibratory NDT and aircraft loads are shown in Figures 20 and 21. Again, these findings must be adjusted for the location of the loads and the location of the gages in the pavements.

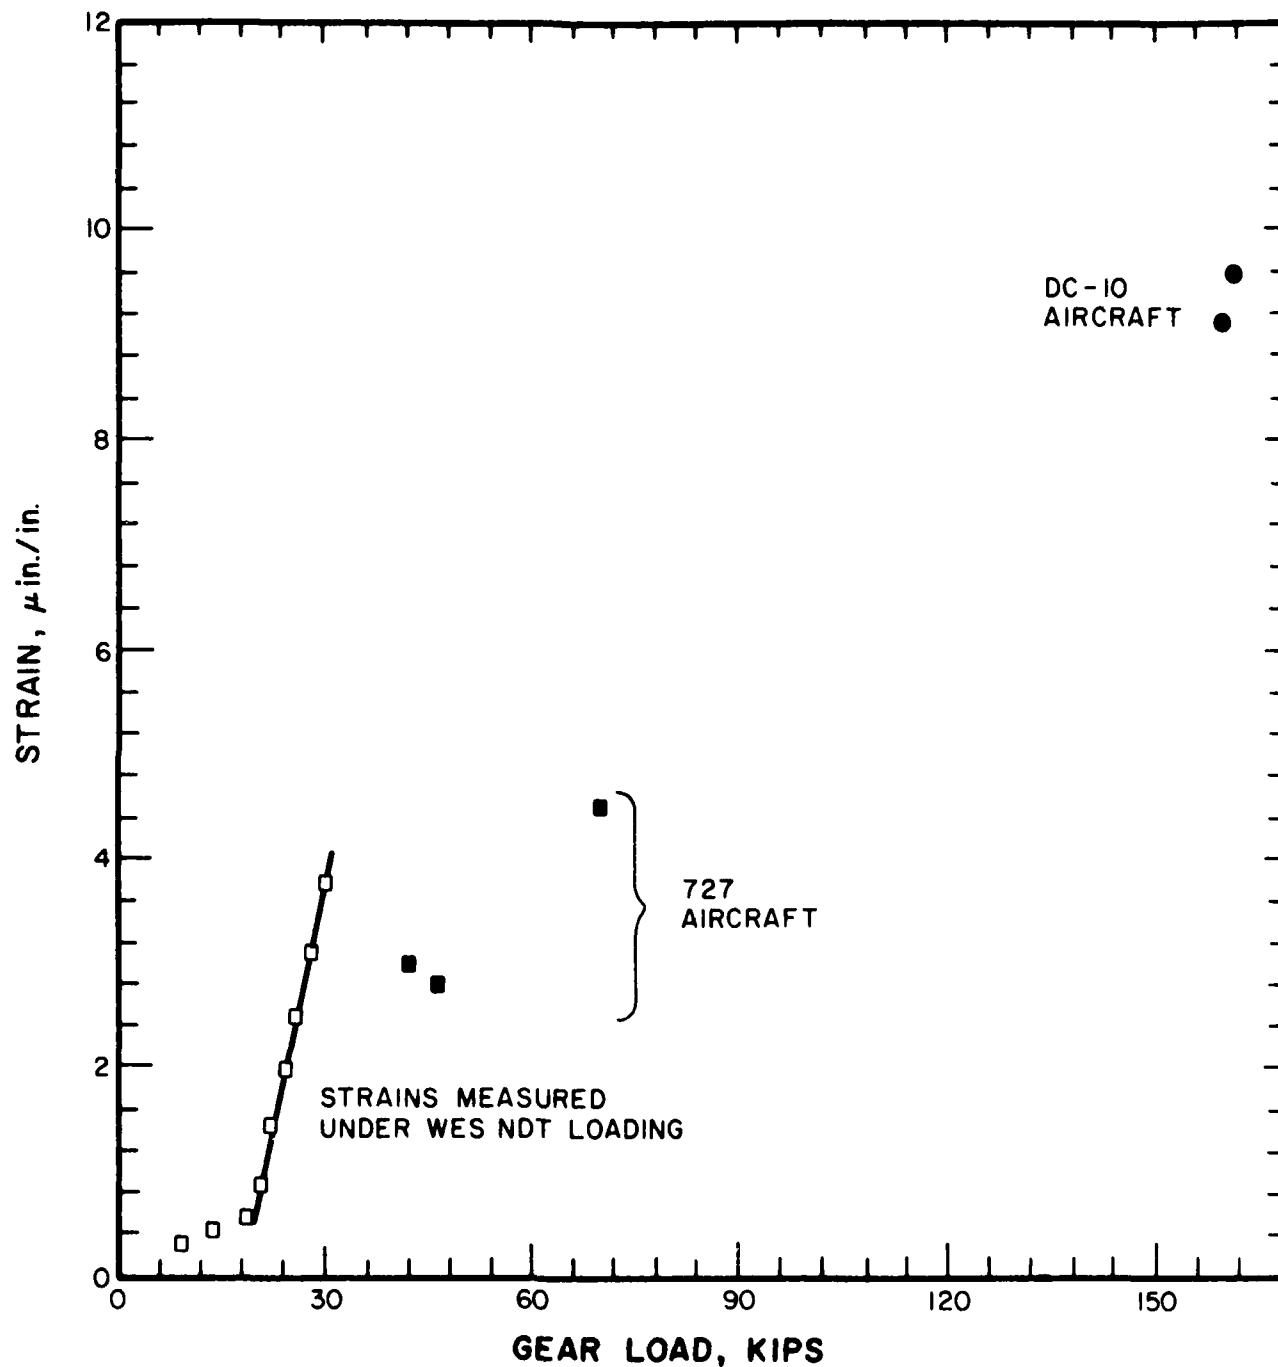
Figure 21. Typical Strain Results from Site #5, with Load at Center of Dowelled Transverse Joint

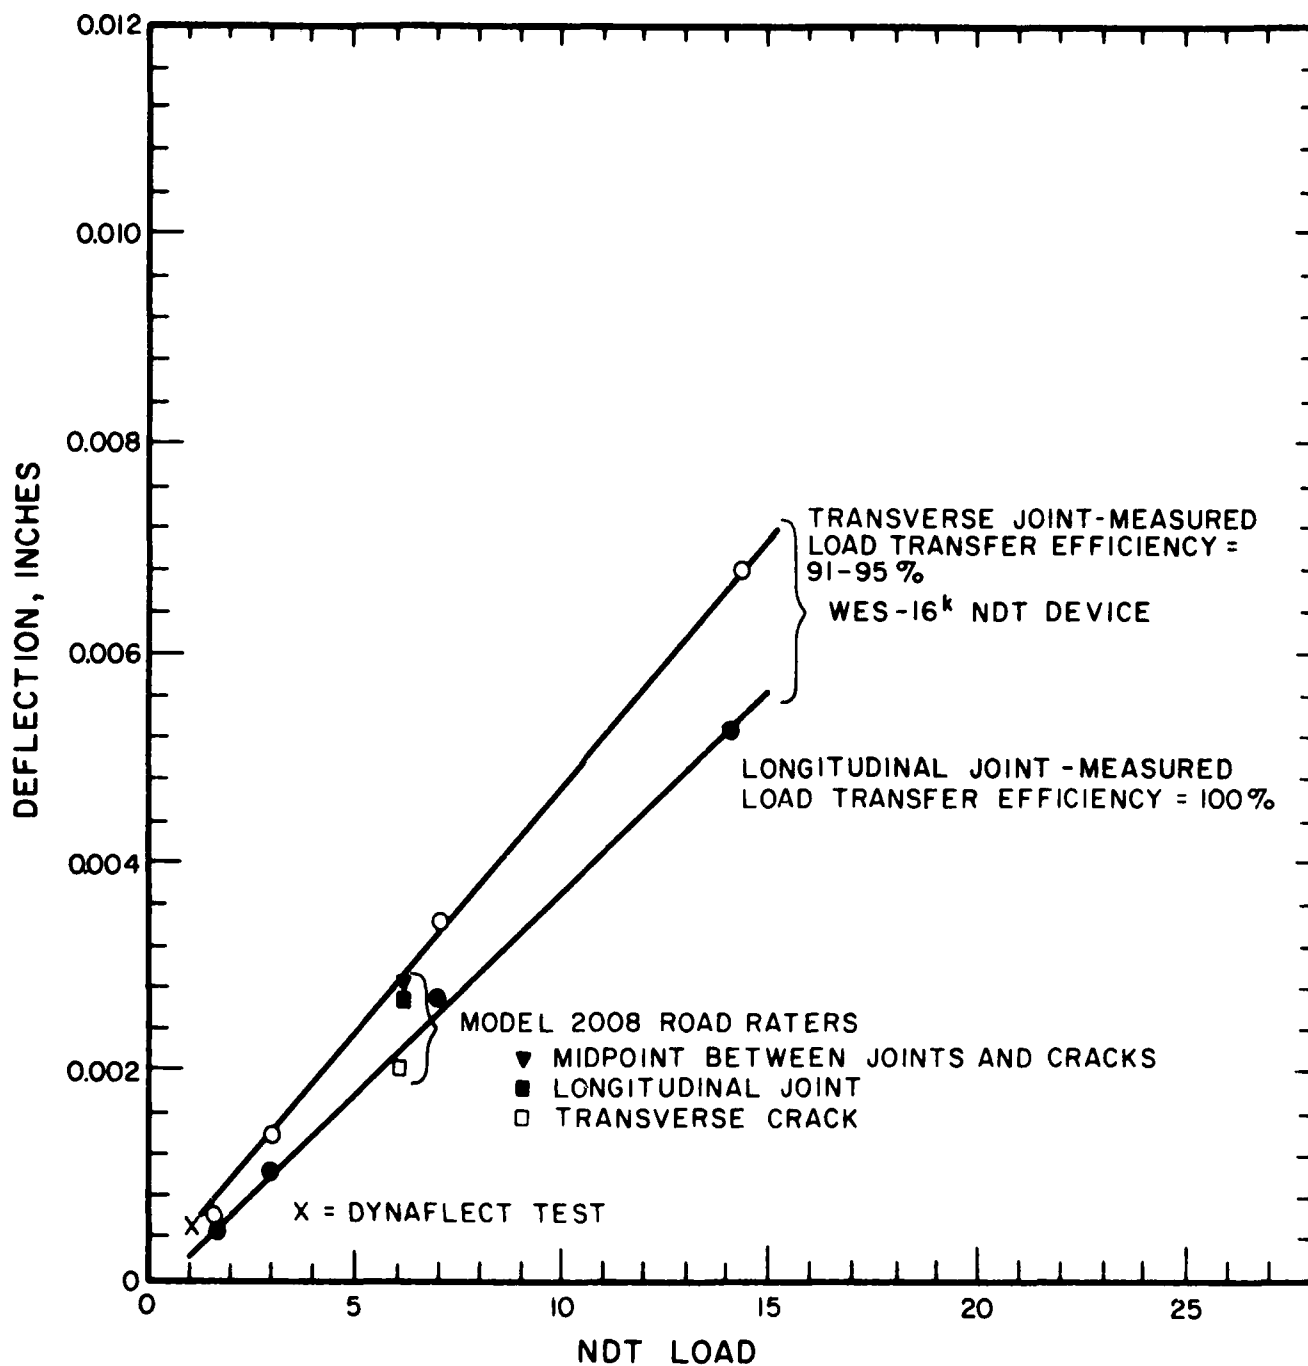
Figure 22. Typical Deflection Results at Site #3, with Loads at Longitudinal Joint and at Transverse Crack

Measured deflections at Site 3 under loading with NDT vibratory devices are shown in Figure 22. Attempts to measure the deflections at Site 3 with aircraft under normal operations proved unsuccessful as the location of the actual wheel paths could not be determined with sufficient accuracy to make comparisons.

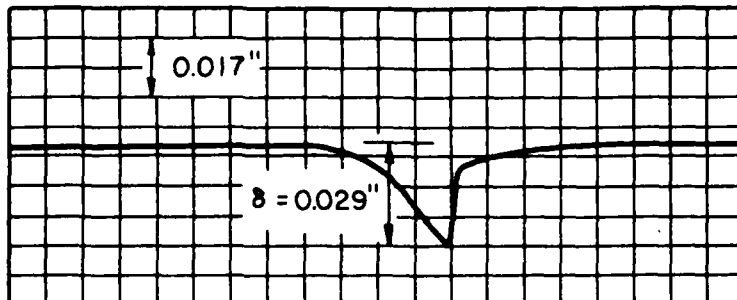
727 NOSE GEAR EST. LOAD = 7000 Pounds

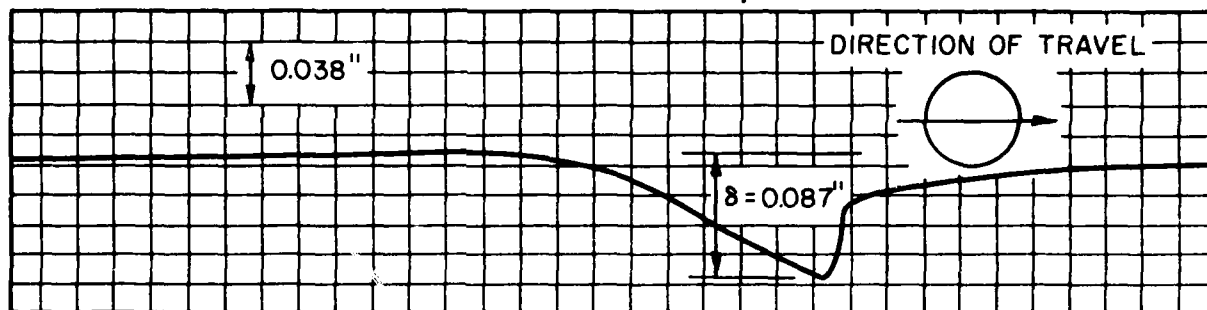
727 MAIN GEAR EST. LOAD = 46,750 Pounds

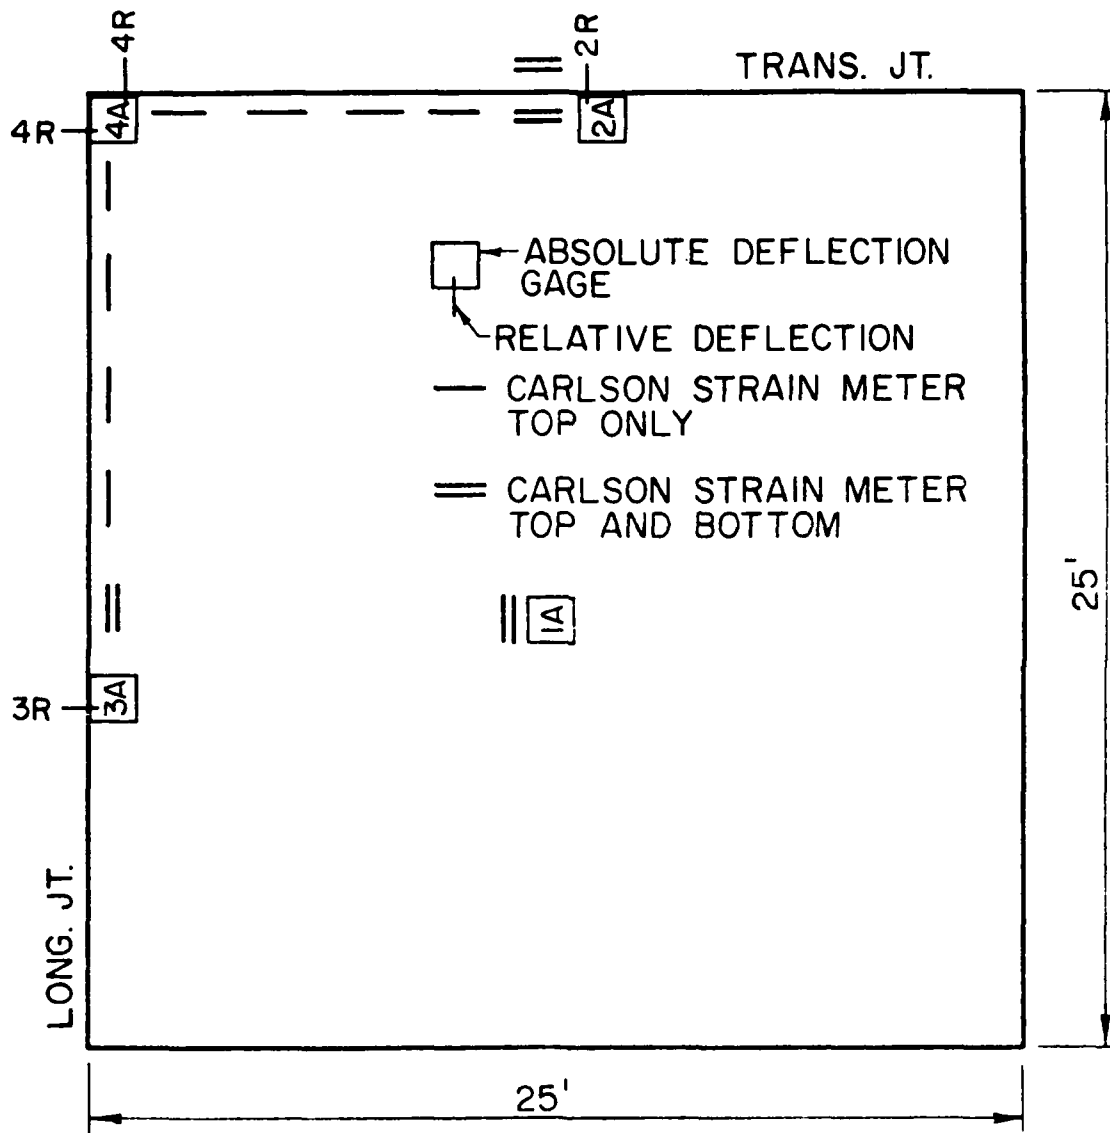
TYPICAL SLAB INSTRUMENTATION

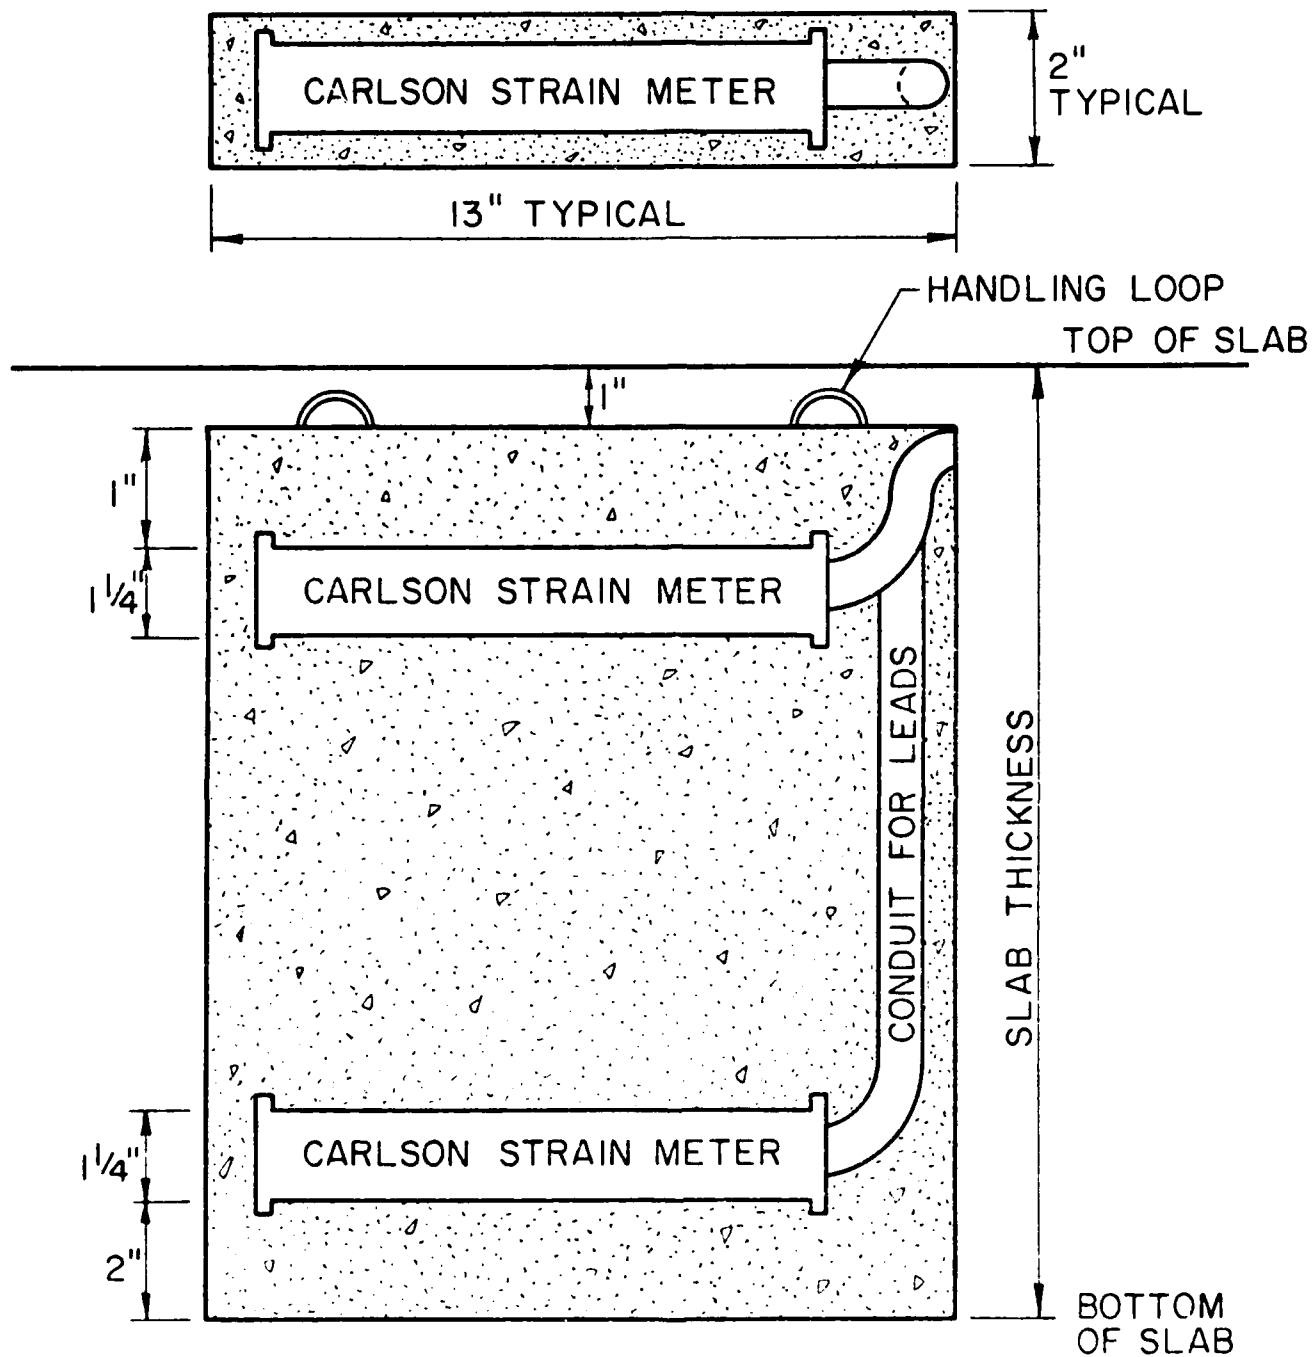
INSERTS FOR INSTALLATION OF STRAIN METERS
